FIRE - PREVENTION REPORT

**HIGHWAY DEPARTMENT
STATE OF NEW JERSEY**

**W. S. BORDEN CO., AGENTS
TRENTON, NEW JERSEY**

GENERAL COMMENTS
Fernwood Station, Trenton, N. J.

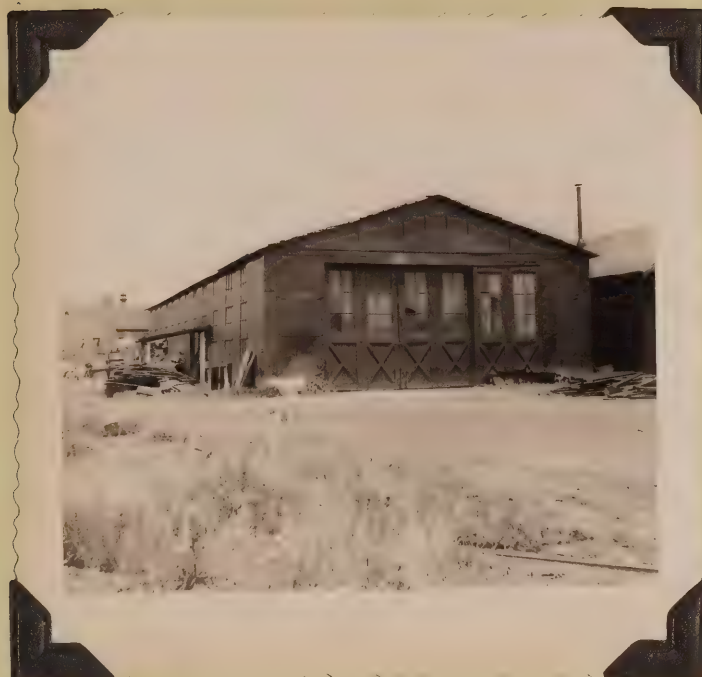
Storage Building #4

Construction One story, metal walls on metal frame.
Metal roof on light steel truss. Concrete
floor and foundations. One wooden interior
partition. No heat; no lights.

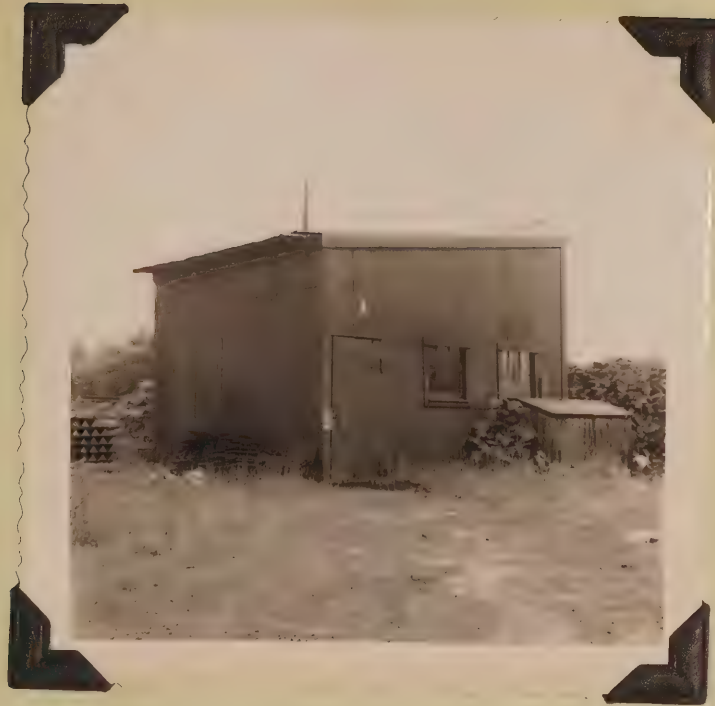
Storage Building #6

Construction One story, corrugated iron walls on wood studs. Board floor. Metal roof. Electric lights, wiring in BX. No heat.

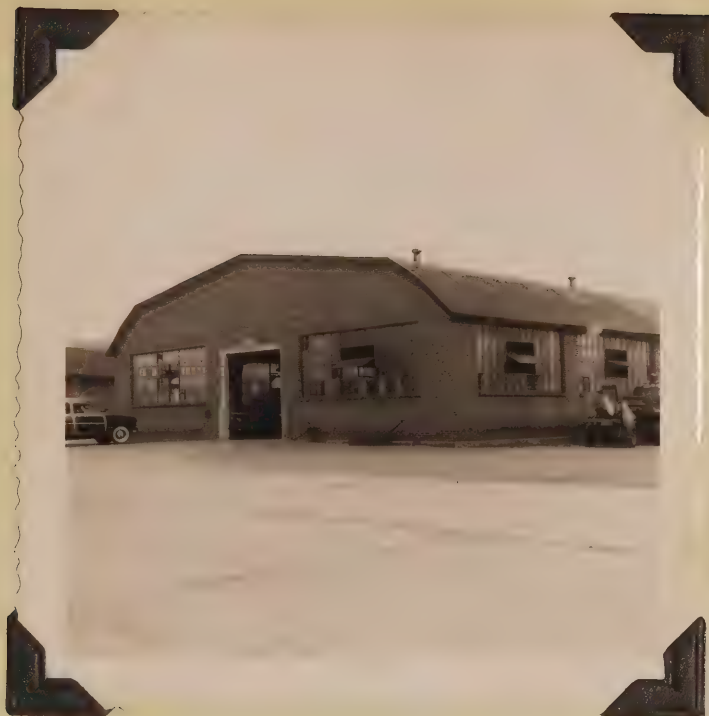
Garage Building #8

<u>Construction</u>	One story, brick (same as Building #7)
<u>Occupancy</u>	Storage of State-owned passenger cars only.
<u>Mechanicals</u>	Steam heat, outside source. Wall radiators. Electric lights - conduit and BX. Plumbing facilities for car washing only.
<u>Fire Extinguishers</u>	Five 2½-gallon foam, one 2½-gallon pump tank, two C.T.C. (1 qt.). Several sand pails.
<u>Suggestions</u>	Replace non-standard 5-gallon gasoline can located in car washing department with Underwriters' Laboratories labeled safety can.
<u>Values</u>	
	Building - \$18,750. Contents - 50. Total \$18,800.

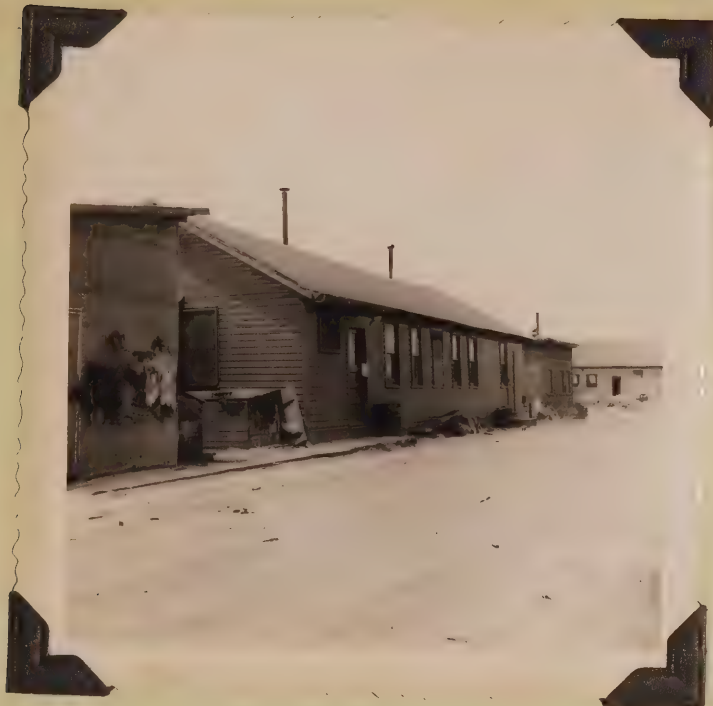
Storage Building #16

<u>Construction</u>	One story, frame, composition roof covering. Concrete foundations. Wood floor. Matched board ceiling.
<u>Mechanicals</u>	Stove heat. Electric lights - wiring in B.B.
<u>Extinguishers</u>	One 2½-gallon pump tank, one 2½-gallon soda-acid and one 1-quart C.T.C.
<u>Occupancy</u>	Miscellaneous storage maintenance department, ladders, paints, lumber, etc. Battery charging.
<u>Values</u> (as of 1/1/49)	Building - \$375. Contents - <u>100.</u> Total - \$475.

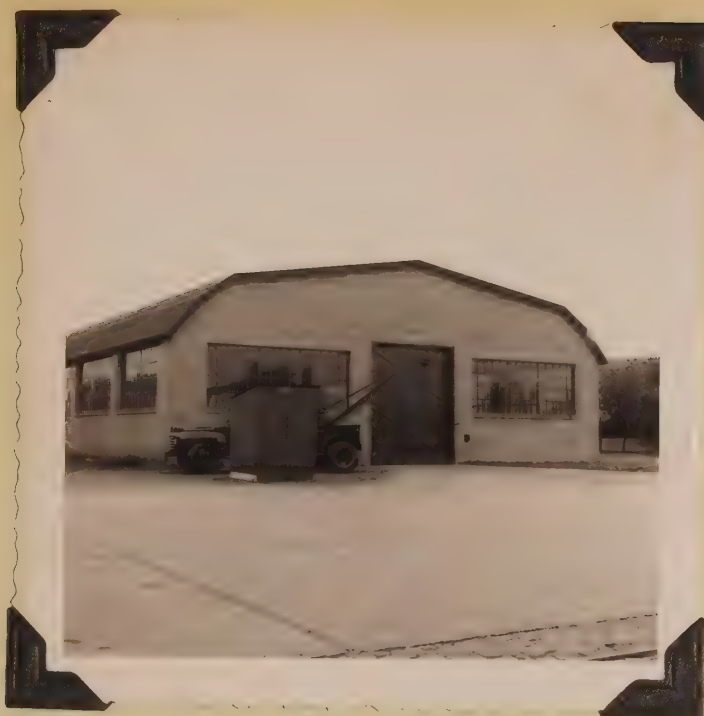
Storage Building #17

<u>Construction</u>	Same as building #11.									
<u>Occupancy</u>	Storage of trucks, Diesel scrapers, tar bottle buggies, etc. in south end. Storage of State confiscated liquors, stills, bar equipment, etc. in north end.									
<u>Mechanicals</u>	No heat. No lights. No plumbing.									
<u>Suggestions</u>	Replace non-standard 5-gallon gasoline cans with Underwriters' Laboratories labeled safety cans.									
<u>Furniture/Fixtures</u>	Two 28-gallon pump tanks, two 1-quart C.T.C. and 3 sand pails.									
<u>Values</u>

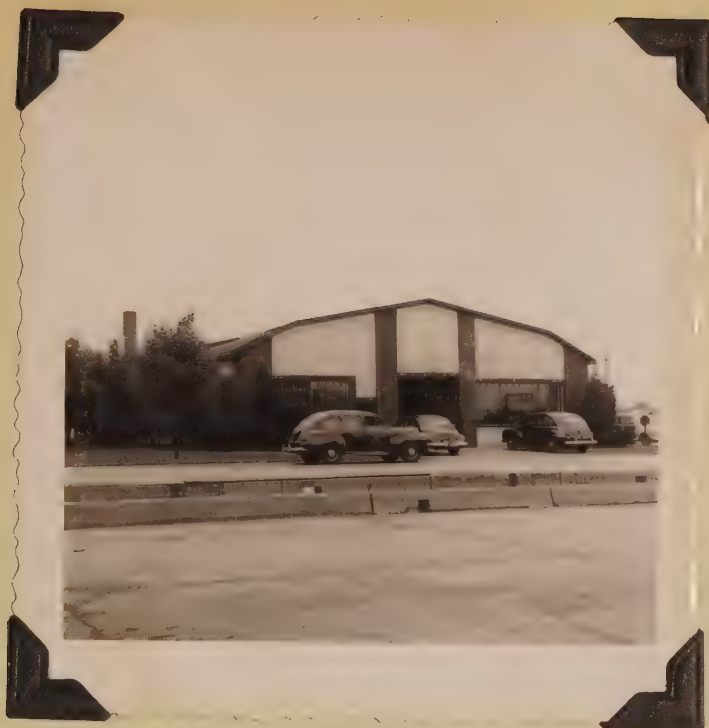
Office and Storage Building #20 and #10A

<u>Construction</u>	One story, cement block, brick pilaster walls. Composition covered roofing on 2" plans on steel truss roof. Concrete floor and foundations. Cement block interior partitions.									
<u>Mechanicals</u>	Hot steam. Asbestos-covered low pressure U.S. Radiator Corporation boiler with Ray oil burner. Unit heaters. Electric lights, modern installation.									
<u>Occupancy</u>	Offices, drafting rooms, stock room, storage of electrical equipment and supplies, experimental laboratory room, truck storage, battery charging, etc.									
<u>Values</u> (as of 1/1/49)

Remove accumulation of loose excelsior from electrical supply storage loft section.

Provide Underwriters' Laboratories labeled safety cans to replace non-standard gasoline cans located in experimental laboratory room.

Keep combustibles clear of stove located in this room and make stove pipe tight-fitting at connection to chimney.

Provide aisles between stored cases of electrical supplies in main room.

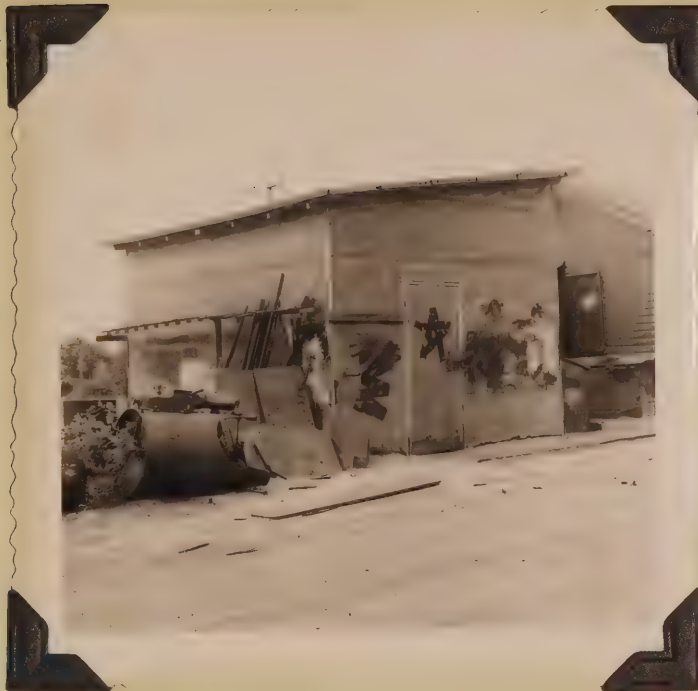
Storage Building #20

Construction One story, frame, composition-covered
walls and roof. Wood floor. No heat
or lights.

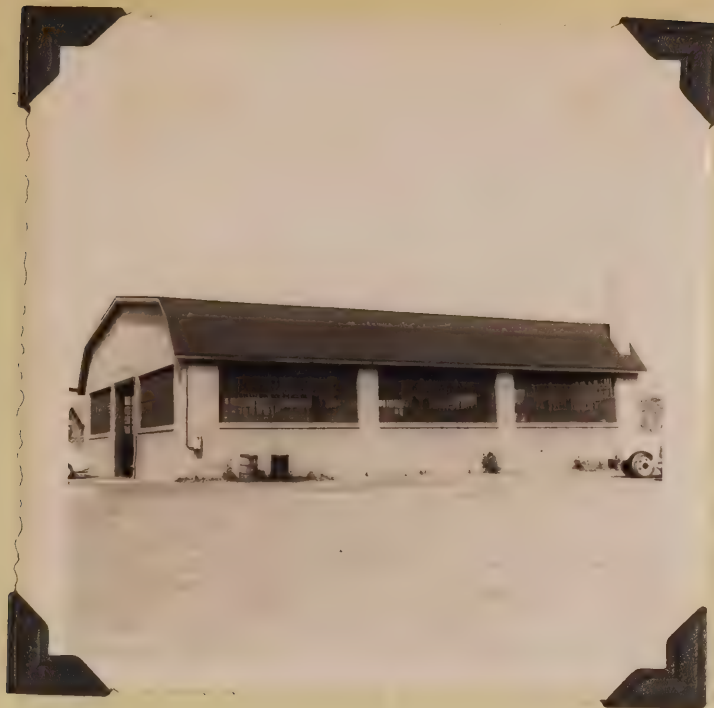
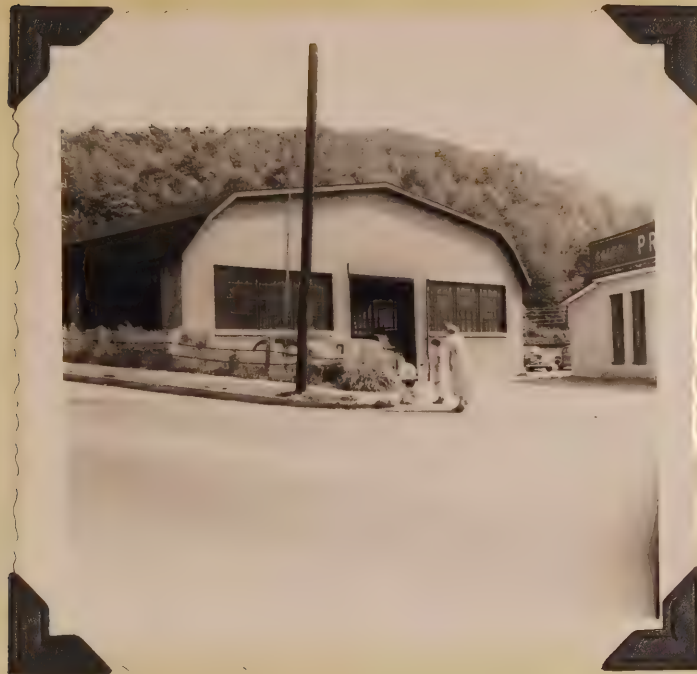
Dover Garage
228 East Blackwell St.

<u>Construction</u>	One story, cement block. Concrete floor and foundation. Composition roofing on 2" plank on 3" x 12" wood purlins on steel truss. Interior walls and roof painted.
<u>Mechanicals</u>	Electric lights. Wiring in conduit. Steam heat. Suspended unit heaters. Kewanee Type B. low pressure coal-fired boiler. Ordinary plumbing facilities.
<u>Occupancy</u>	Storage garage. Occasional repair work.
<u>Values</u> (as of 1/1/49)	Building - \$8,900. Contents - <u>2,673.26</u> Total \$11,573.26
